NATIONAL AERONAUTICS AND SPACE ADMINISTRATION

FINAL REPORT

DELTA 85 ANOMALY REVIEW COMMITTEE

DECEMBER 1, 1971

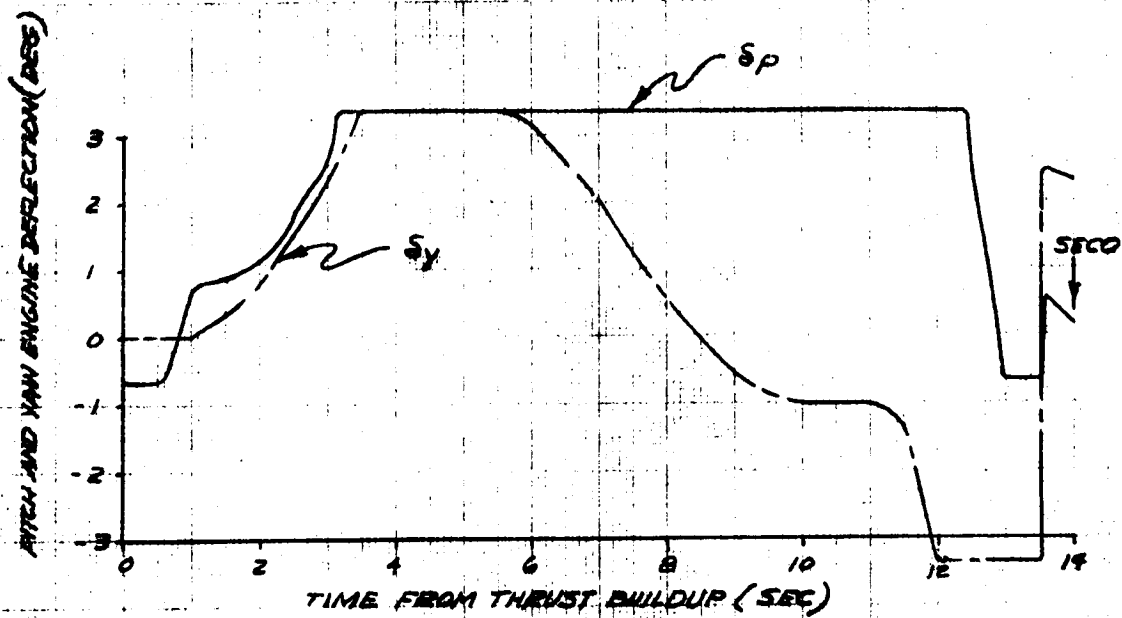
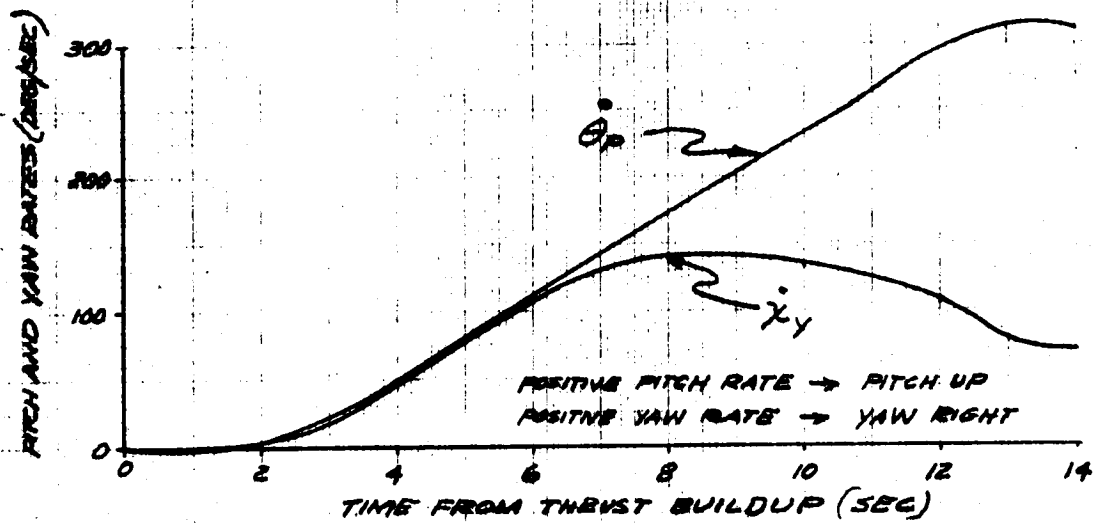
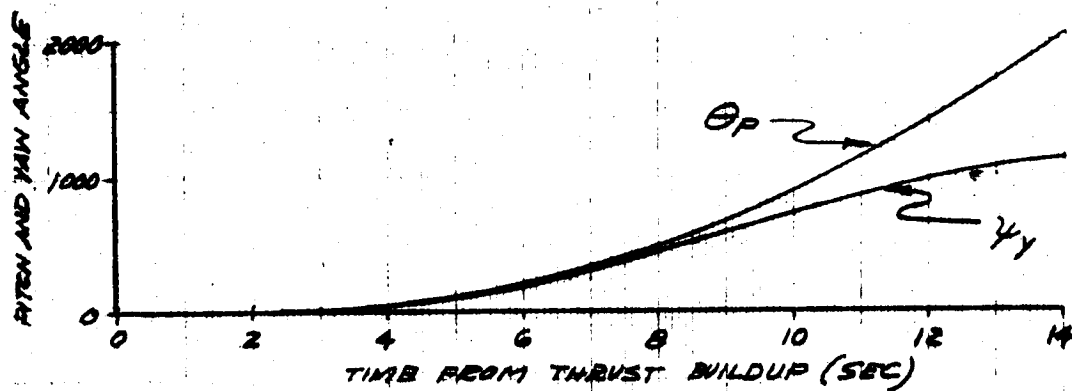
FIGURE 2-8, OSO-H SECOND STAGE VEHICLE DEFINITION

Figure 2-8 defines the location of the VCS along with other pertinent parameters. The integration of engine motion results in the vehicle rates indicated in Figure 2-9. These rates cause a centrifugal acceleration which counteracts the axial acceleration caused by engine thrust. This "negative" acceleration results in a lower VCS output than would be expected during normal operation. Figure 2-10 shows the actual telemetered VCS output along with calculated outputs for second stage thrust levels of 6400 lbf to 6800 lbf. Good correlation between the actual and predicted VCS output is evident, confirming that VCS operation was normal when vehicle motion is considered, and that it should not have issued a SECO command.

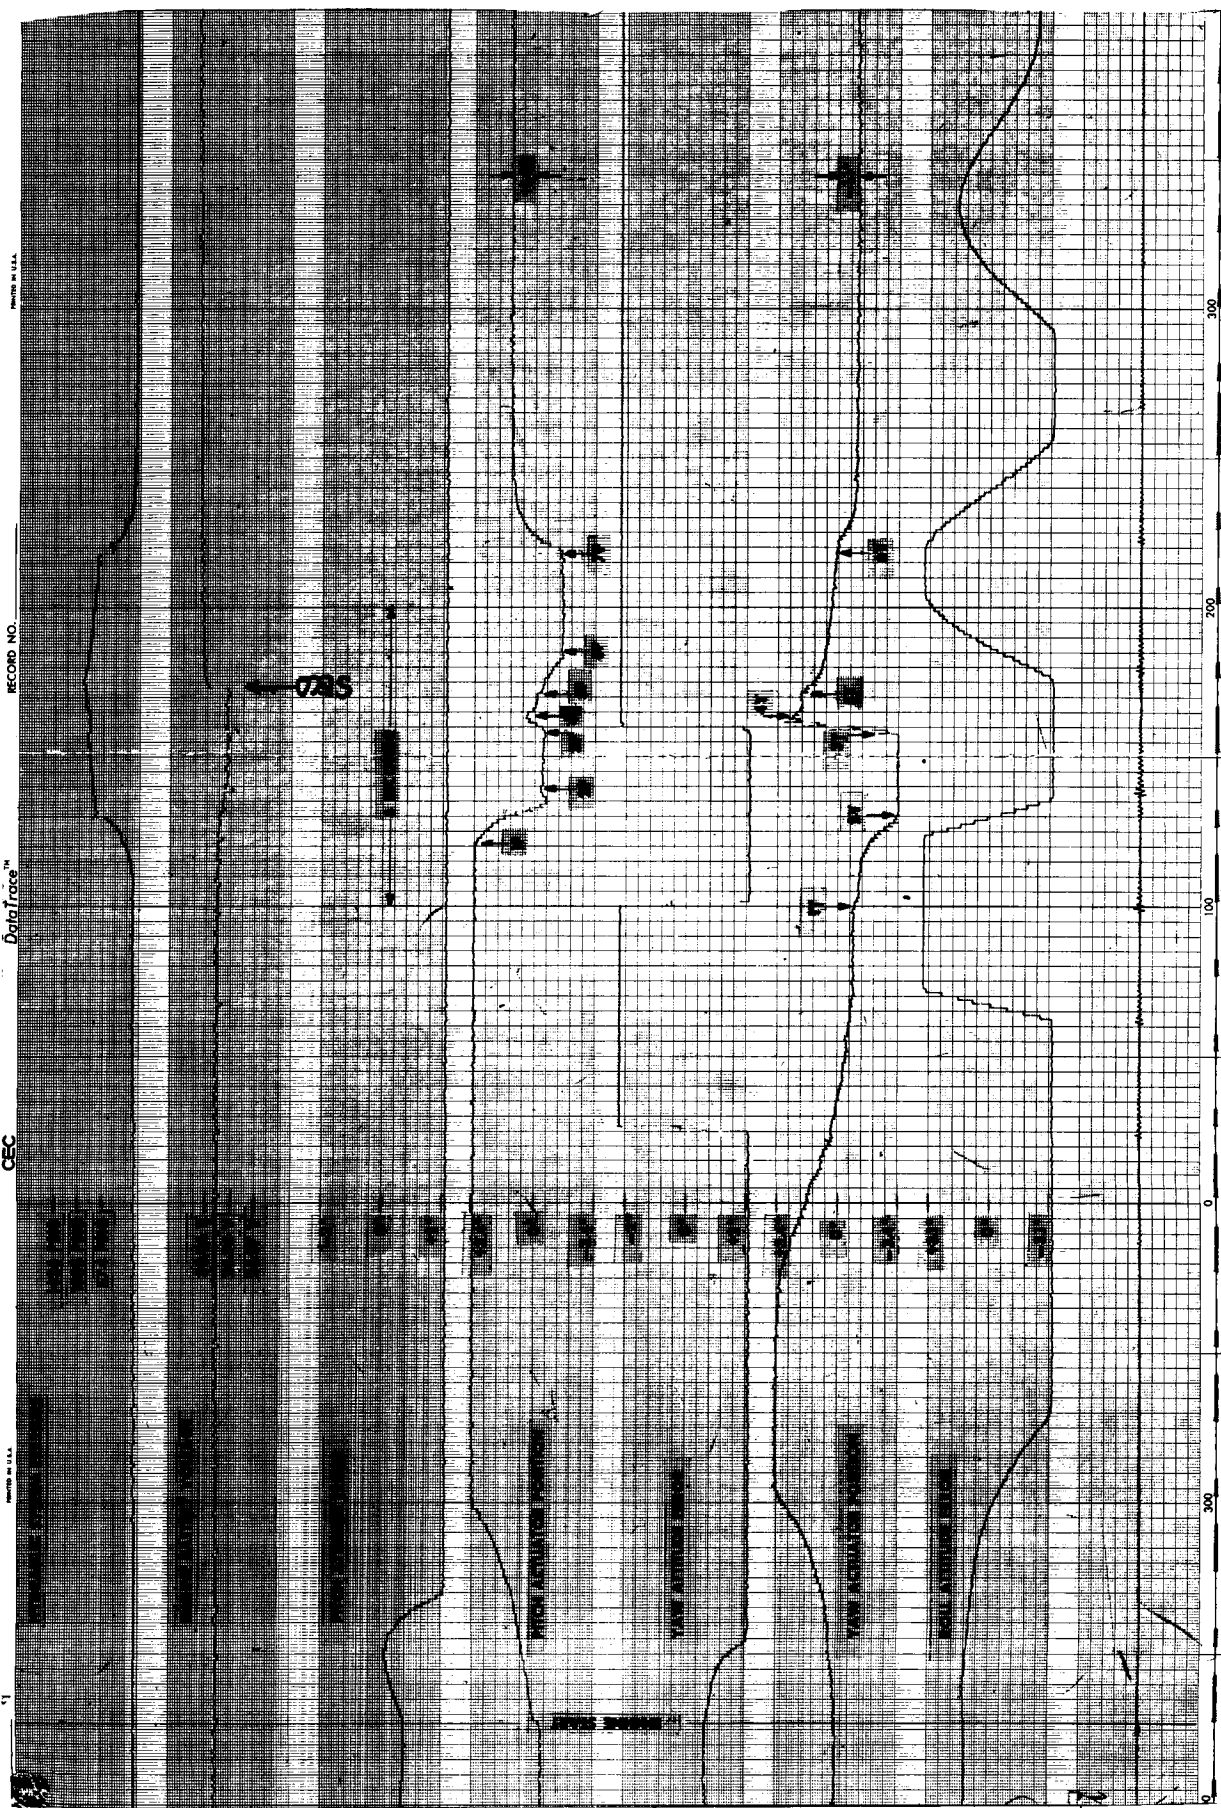
FIGURE 1

As seen from Figure 1, shortly after ignition both actuators hit their +3.4 degree stops. This motion is attributed to thrust misalignment with respect to the engine pivot point. These torques were calculated to be 208 ft-lb in pitch and 56 ft-lb in yaw. The pitch thrust misalignment torque was calculated using the fact that the pitch attitude error rate is zero .84 seconds after ignition and the model:

Table 1 shows these torques for various points on Figure 1 where the actuators are stopped.  $T_{\dot{\theta}}^2$  was computed using 65 rpm. Also, the actuator position required for equilibrium was computed and a comparison of columns (1) and (2) shows the degree to which the gimbal torque model actually fits the observed actuator motion.

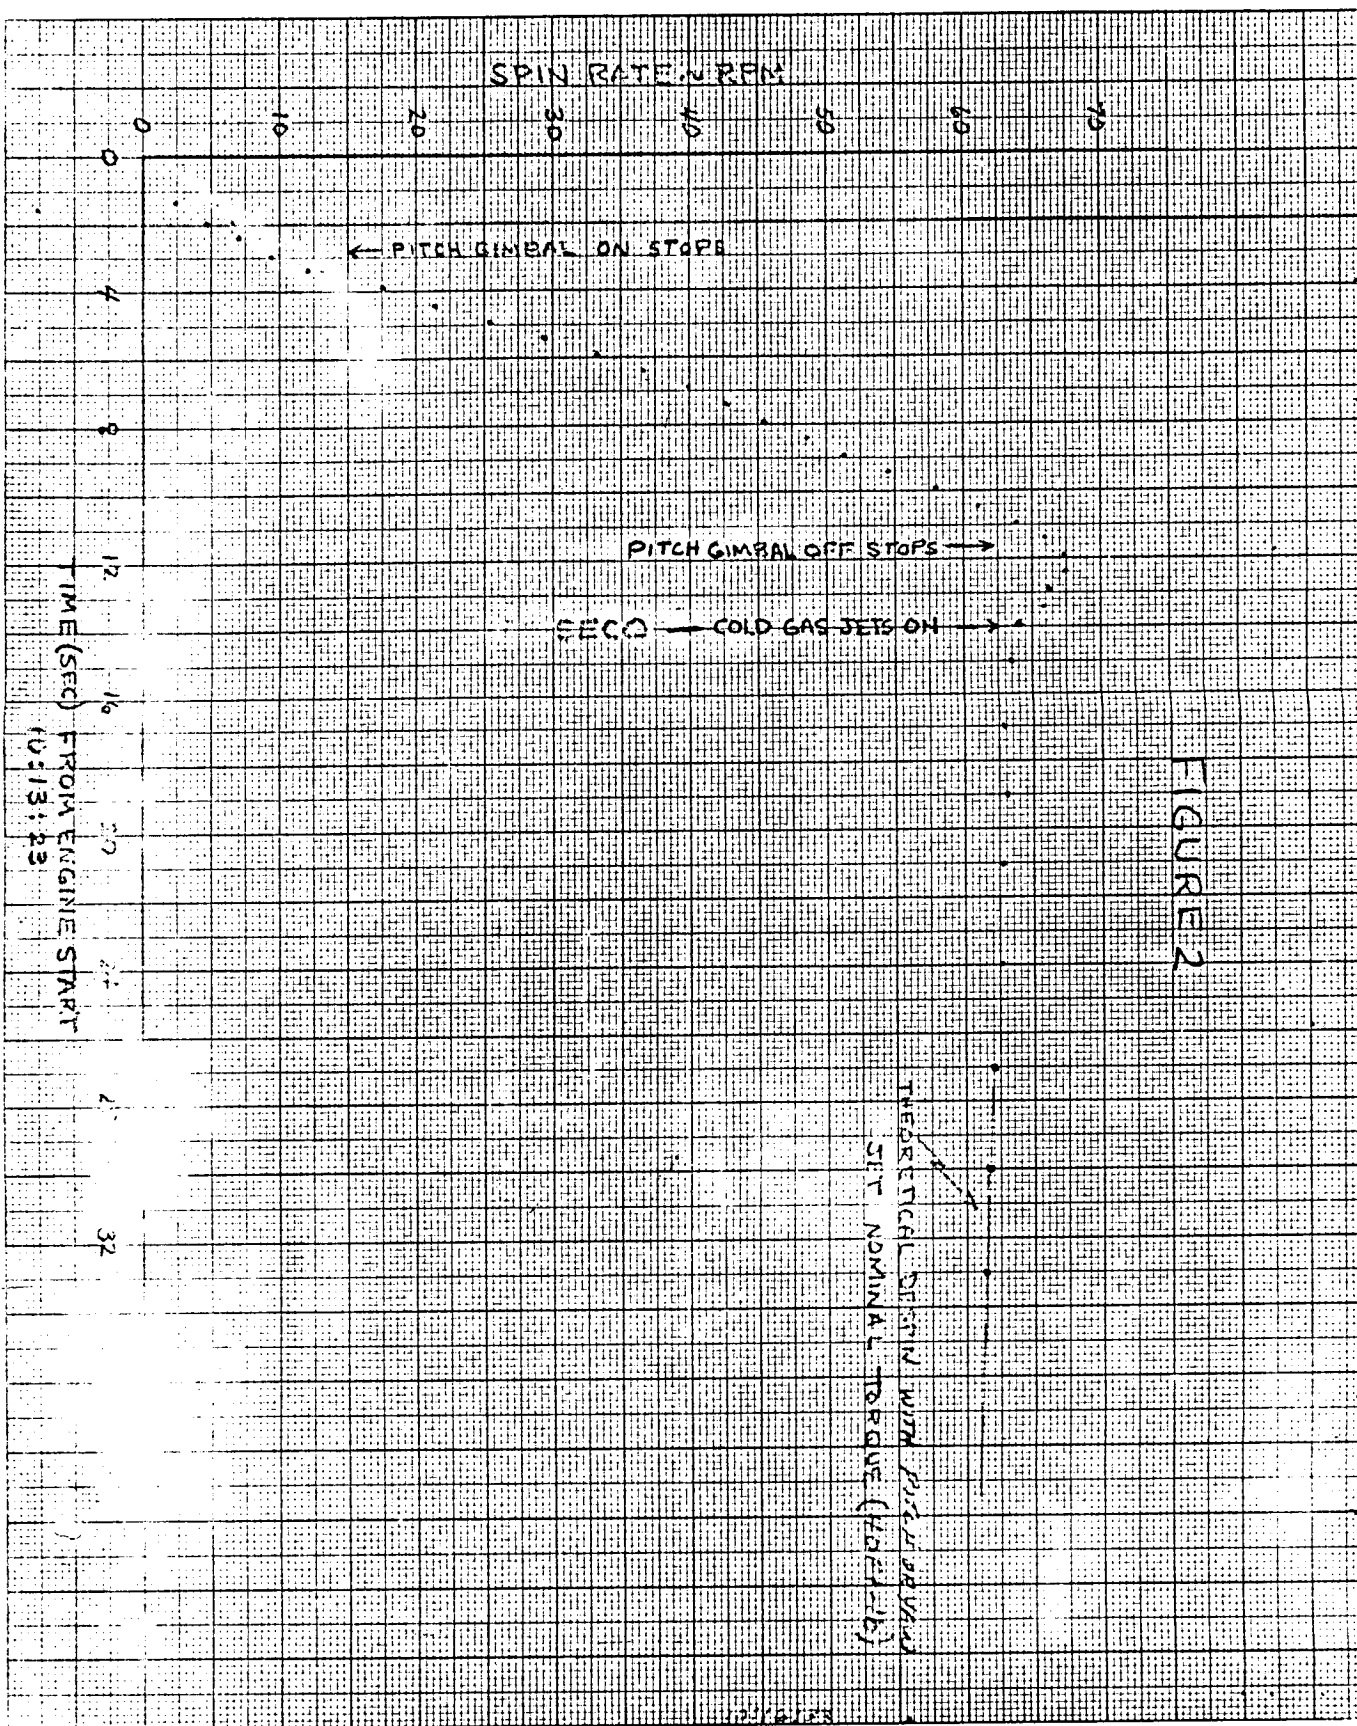
FIGURE 2

The Resulting Spin Rate time history is shown in Figure 2, where the 67 rpm peak rate occurs shortly after the pitch actuator comes off its stop. The change in the rate after SECO corresponds quite closely to the theoretical change expected from either the pitch or yaw jet torques (40 ft-lb) both of which are activated at SECO. The spin rate at payload separation was approximately 55 rpm.

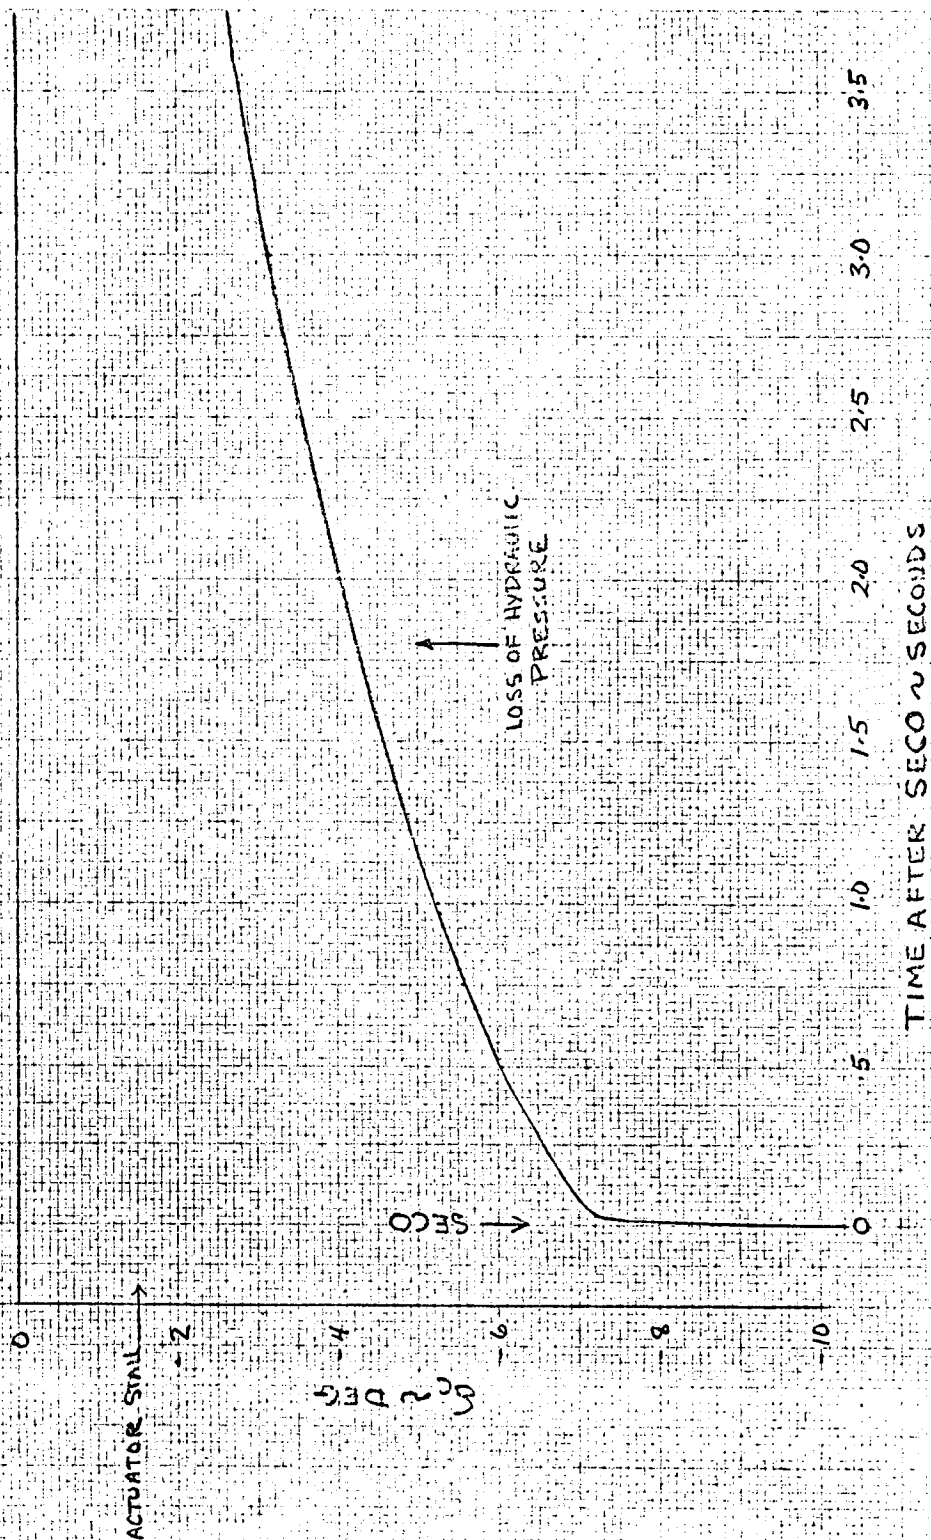
Figure 2 shows the command time history which is negative for the 2 second period after SECO. Moreover, this command is always more negative than the actual actuator position which stops at -1.5 degrees due to the cancellation of the available hydraulic torque by the inertial torque (Ref. 1). Clearly then, the "Non-Centering" pitch actuator motion after SECO is caused by the negative electrical command to the servo actuator.

FIGURE 1  
PITCH ACTUATOR ELECTRICAL COMMAND  
AFTER SECO (DELTA 85)

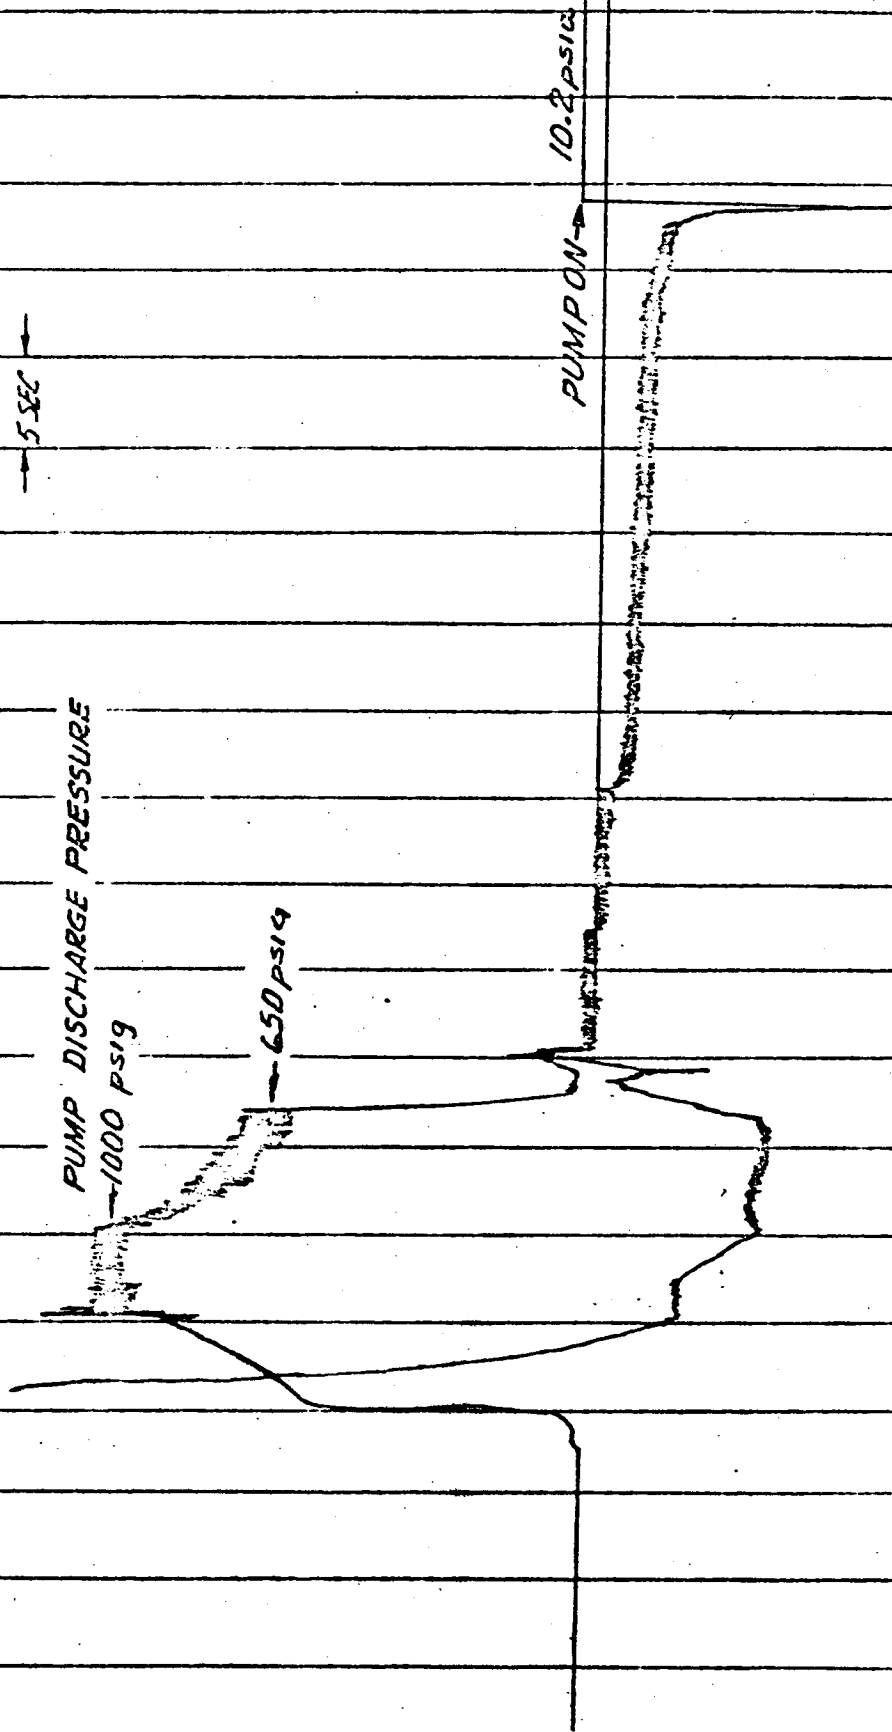
FIGURE II-5

RESERVOIR PISTON STUCK TEST  
1<sup>ST</sup> BURN UNTIL TEMP REACHED 202°F  
CLAMPED PISTON AT 151°F AND  
HELD FOR 10.8 MIN. BEFORE RESTART
